Service report

Integrity testing

Alfa Laval heat exchanger integrity testing service report

2.1 Cold block cooler

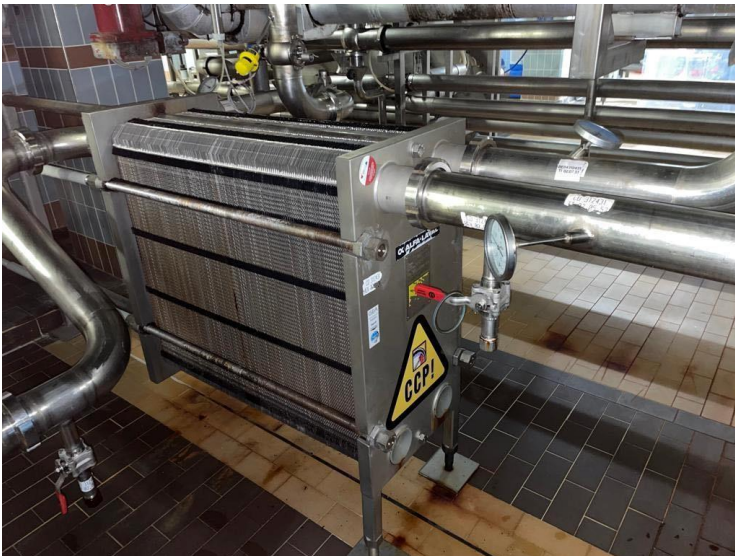
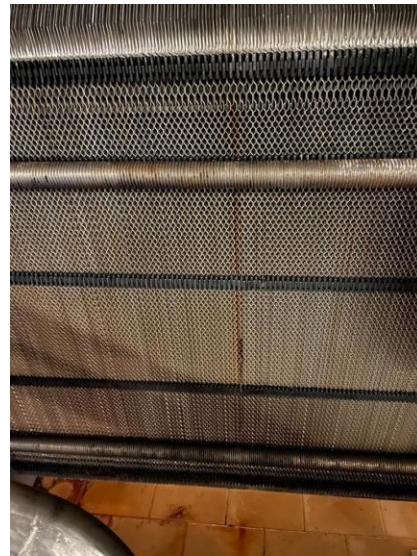
There are 279 plates in the cold block cooler. The actual installation size (after tightening) is 934 - 935mm.

End conclusion: this plate pack has sustained damage to its plates that can lead to internal leakage. A leak trail can be seen in the middle of the plate pack (see the second picture above). This is probably at the level of the baffles. A pressure surge at the level of these baffles may be the cause of this damage.

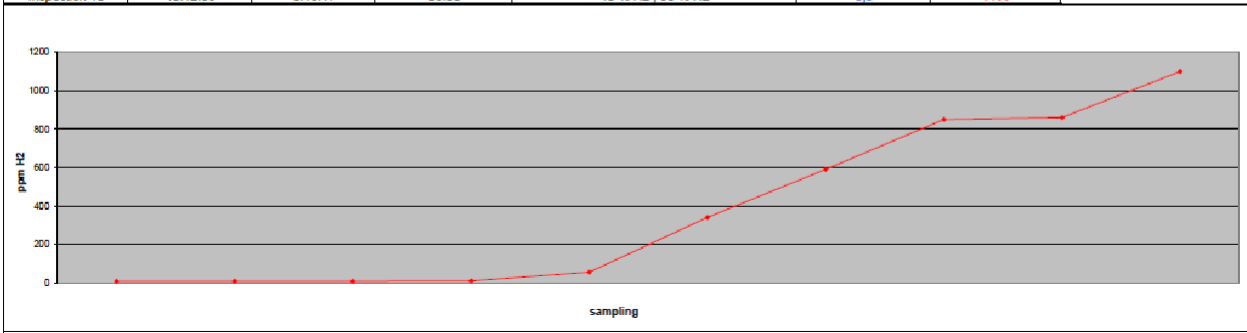
Forming gas was introduced on S4 and T4. Compressed air was introduced on S1 and T1. From 3 bar upwards, the forming gas levels in the compressed air circuit start rising (see the chart below).

The sniffer was positioned on the compressed air outlet after the line had been disconnected. This resulted in a measurement of approximately 900 ppm of forming gas.

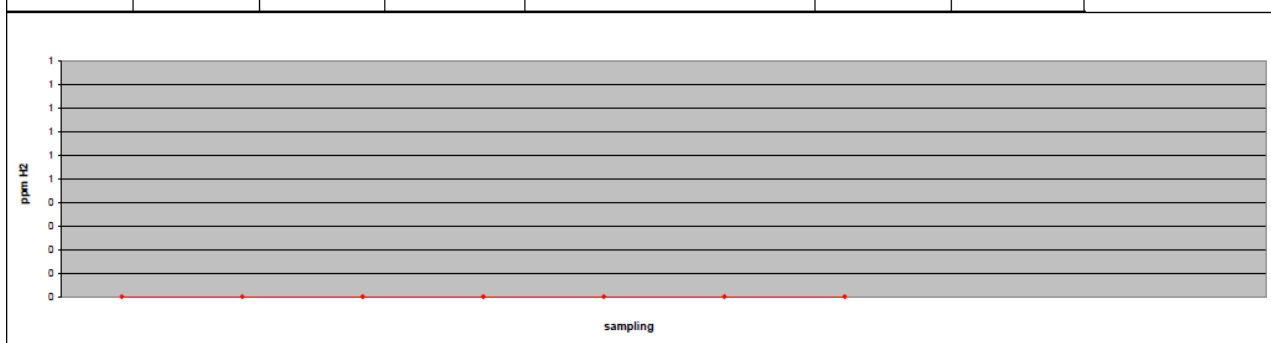
In the 3rd section, forming gas was introduced on the glycol side T4 and T3. Compressed air was applied to the beer side. No forming gas was detected in the compressed air circuit. A 'sniffer' (sensor) was used all around this section. No external leaks were found.

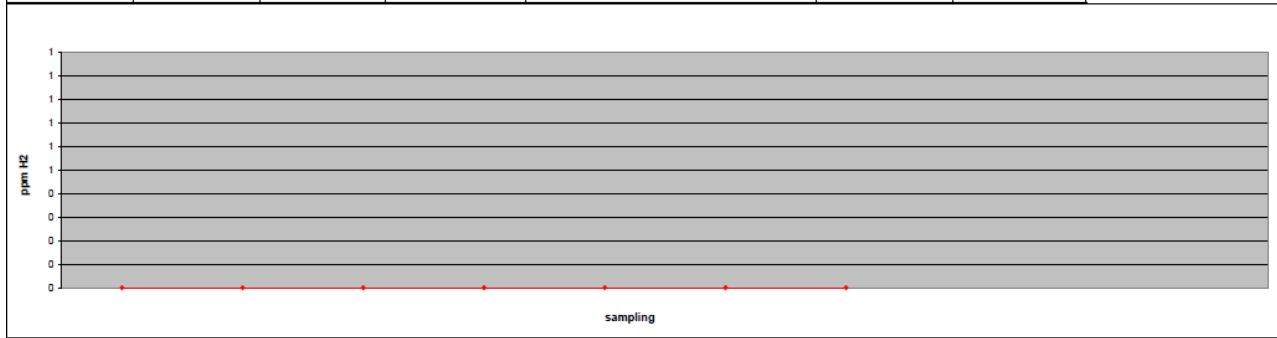
In the 2nd section, forming gas was applied to the beer side and compressed air on the beer side S4. No forming gas was detected in the compressed air circuit. A 'sniffer' (sensor) was used all around this section. No external leaks were found.

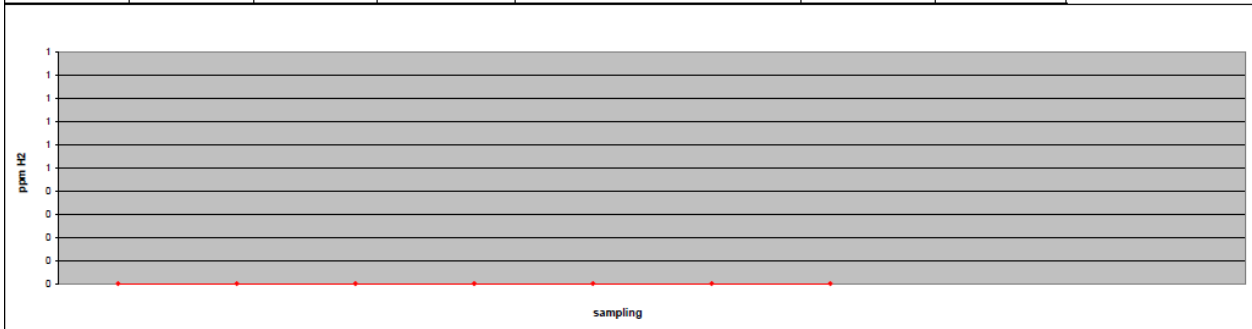
In the 1st section, forming gas was applied to S1-S2 and compressed air on the beer side S4. No forming gas was detected in the compressed air circuit. A 'sniffer' (sensor) was used all around this section. No external leaks were found.

End conclusion: this plate pack is free from damage to its plates that can lead to internal leakage.
